THE HAZARDS OF MEMBRANE ROOF FIRES

BY FRANK C. MONTAGNA

Editor's note: This article originally appeared in the April 1997 edition of WNYF.

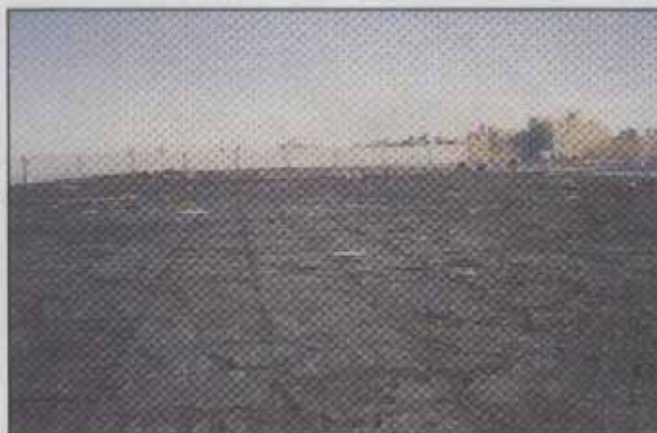
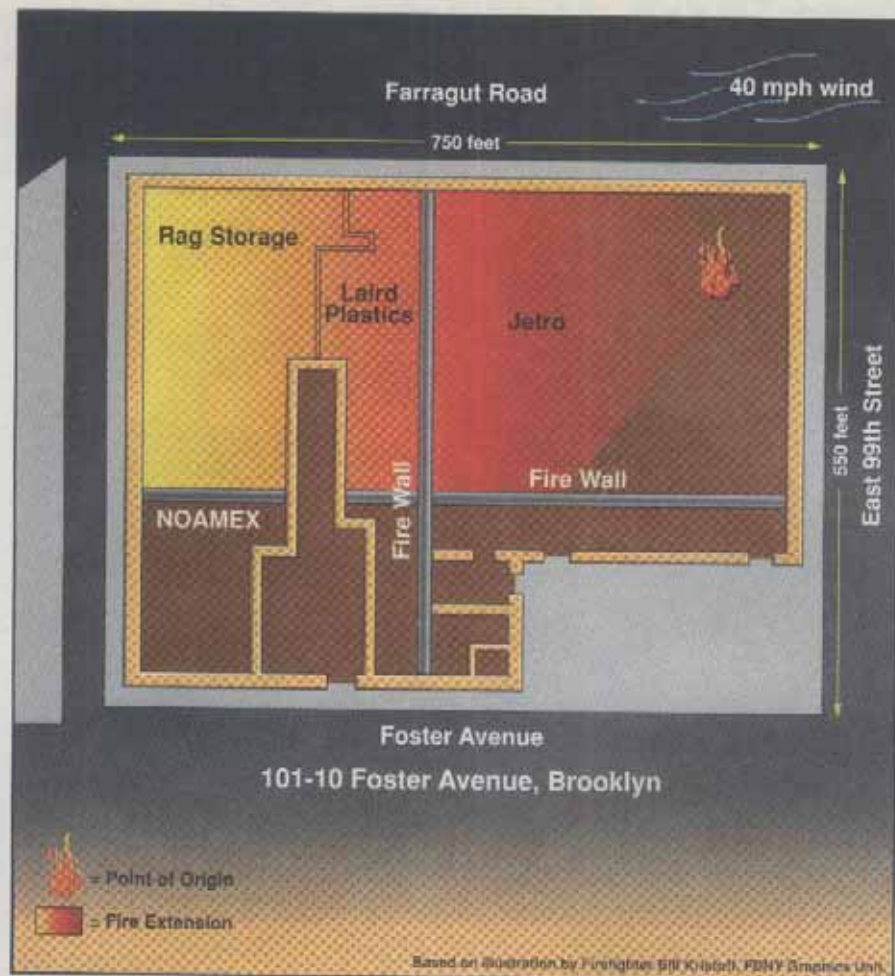
(Top) A firefighter watches as fast-moving membrane roof fire passes him. As the large fire front passes him, it leaves in its wake spot fires not unlike the aftermath of a brush fire. Note that the fire is contained by a small partition rising several inches above the roof. (Bottom) The fire ran the entire length of the 750-foot roof in about 30 minutes. (Photos by author.)

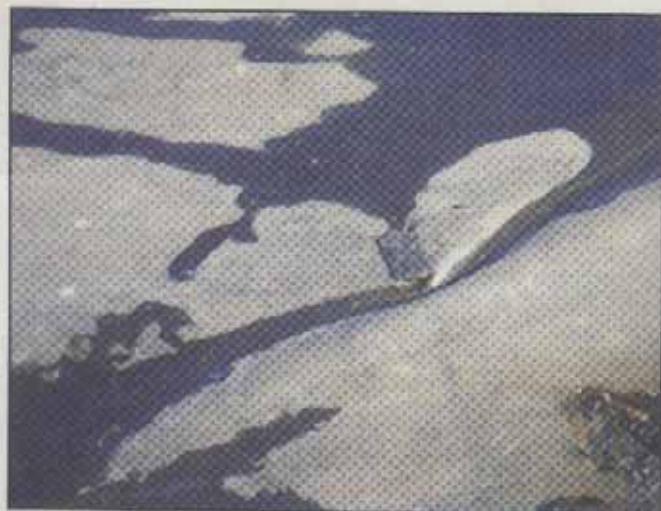
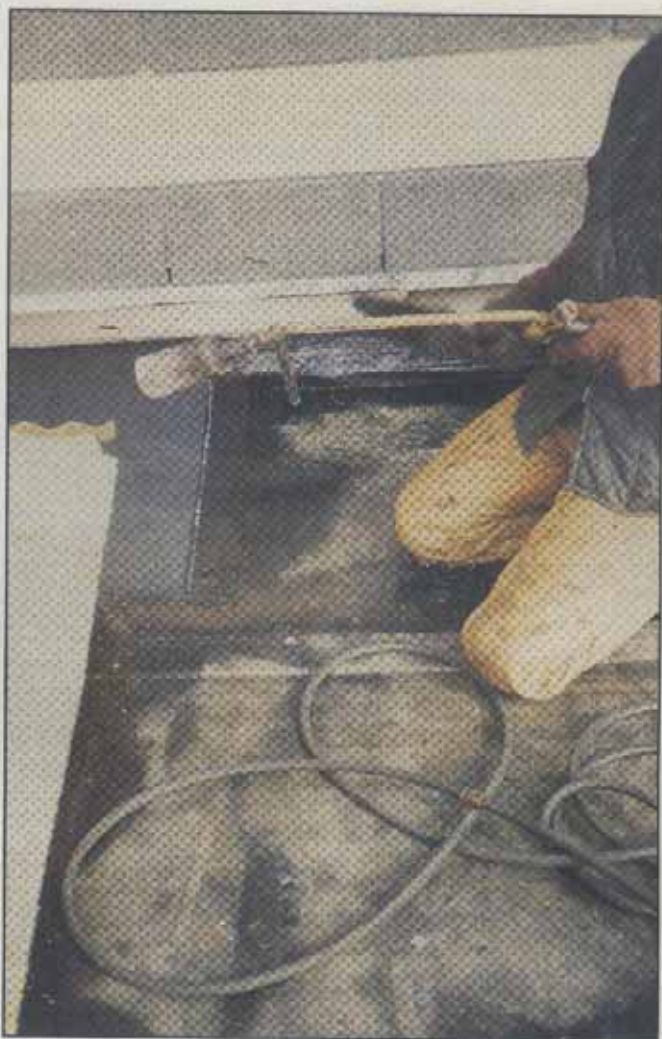
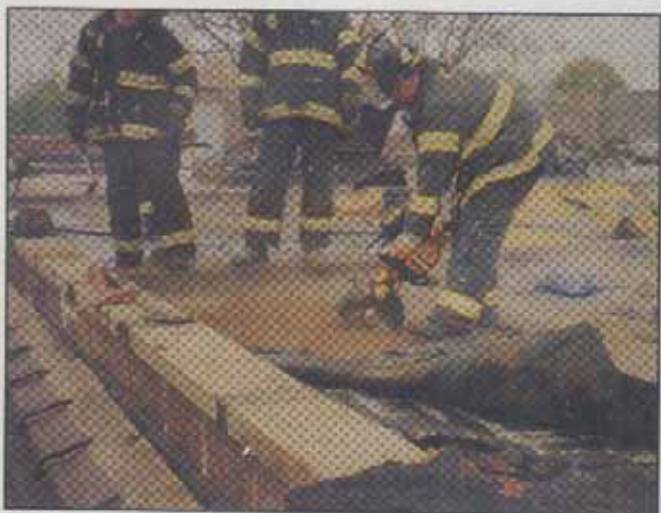
(Top left) EPDM roofing held in place by a metal fastener. (Right) Mod bit membrane roof being torched in place. (Bottom left) Firefighters cutting a mod bit membrane roofing on a Q-deck roof. First, they cut the membrane, then they must cut and pull up the fiberboard insulation. It is an arduous, labor-intensive task. The fiberboard smoldered and spread underneath the membrane. Cutting and pulling over a large area was required to ensure extinguishment.
