What We Learned

BY FRANK C. MONTAGNA

TRUCK EXTRICATION FROM A SINKHOLE

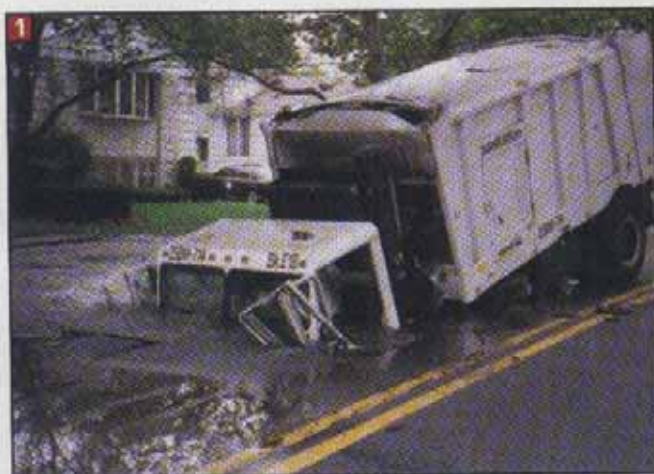
(1) The sanitation truck continued to sink into the hole as more and more of the pavement was undermined and collapsed. (Photos by author.) (2, 3) A large wrecker with a boom lifted the front of the truck while a smaller sanitation wrecker held the rear of the truck in place to prevent it from slipping into the hole. The boom operator then swung the cab onto stable ground.

As our plan was being formulated and as we waited for the monster wrecker, the sanitation truck continued to slowly sink into the hole. This raised a new concern. The truck's diesel fuel tank was being crushed against the pavement. If it continued, diesel fuel could (and did) leak into the standing water and contaminate the water distribution lines. The hydraulic tank was also in danger of being ruptured if the truck sank much more. It was likely that we would face a diesel and possibly a hydraulic fluid spill. To prevent this, the deputy chief requested the response of one of our haz-mat-trained squad units to offload the diesel and hydraulic fluid. The diesel and hydraulic fluid were partially offloaded when the truck again started to settle into the hole, and the pavement around it was in danger of collapsing. The fluid removal operation ceased because of the hazard posed to the squad firefighters. The pavement around the truck might collapse and drop the firefighters into the hole. They also ran the risk of being crushed between the truck chassis and the pavement as the truck settled against the pavement. Some diesel fuel escaped into the sinkhole, but we did at least reduce the severity of the spill.
